Transcend Clinical Case

Dr. Jaleena Fischer Jessop

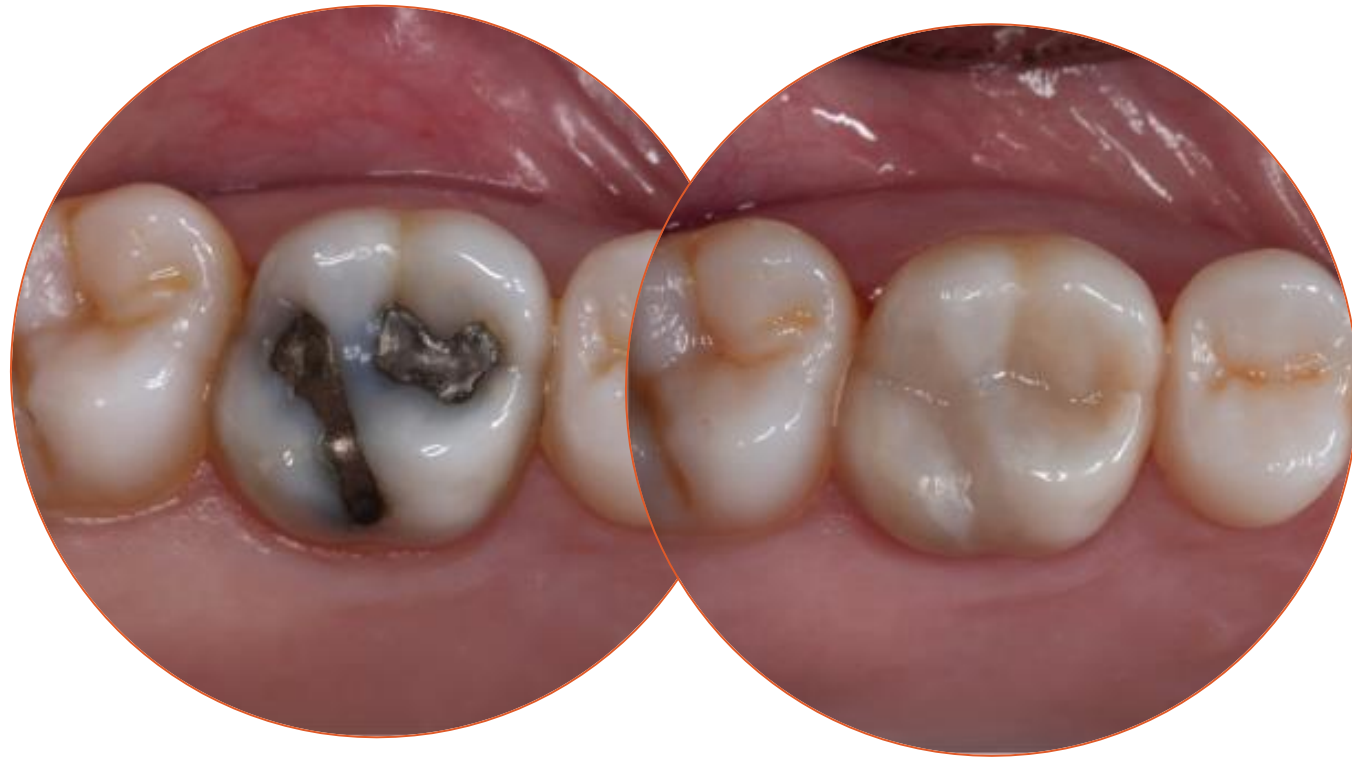
BEFORE

AFTER

Deep staining from amalgam tattooing presents one of the most difficult restoration situations to clinicians. In this case only the Transcend composite Universal Body shade was used to replace the amalgam, no blocker needed. Note the excellent color blending of the preserved oblique ridge.
